# LEAK INVESTIGATION

## *Case Study | Mid-Rise Residential*

*A recurring kitchen ceiling leak persisted through years of inspections, sealant repairs, roofing work, and ultimately replacement of the penthouse roof above. A one-day diagnostic investigation identified the actual water-entry source more than 40 feet away.*

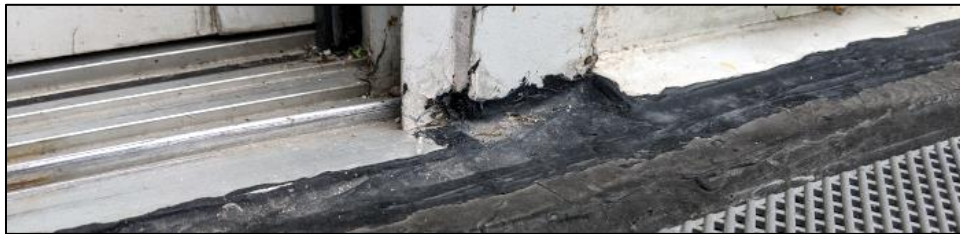
Rather than assuming that the remaining source was directly above the kitchen, the investigation considered the potential for water to enter elsewhere in the penthouse enclosure and migrate through concealed construction before appearing at the reported interior location.

Targeted water testing ultimately identified a water-entry condition at the penthouse parapet and coping.

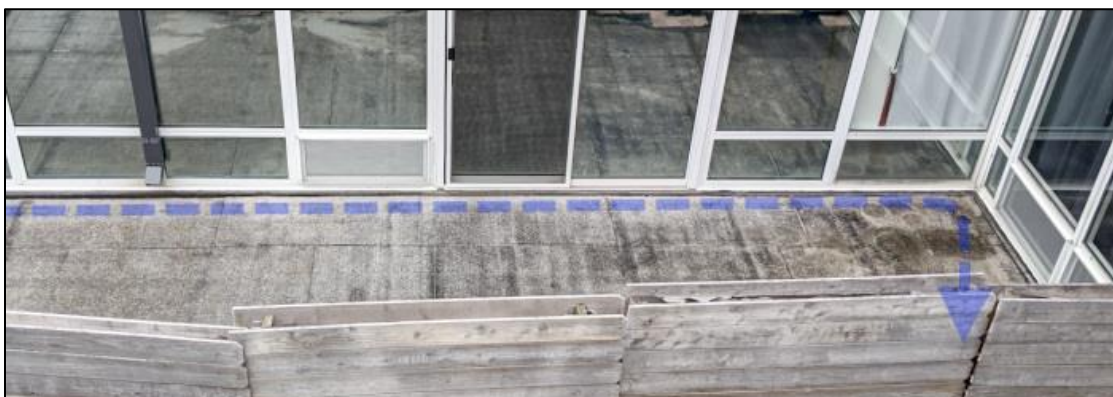
Water entering the enclosure was able to access concealed construction above the structural roof slab and migrate laterally across the terrace assembly.

More than 40 feet from the exterior entry location, the water encountered a pathway into the occupied space below and ultimately appeared at the kitchen ceiling.

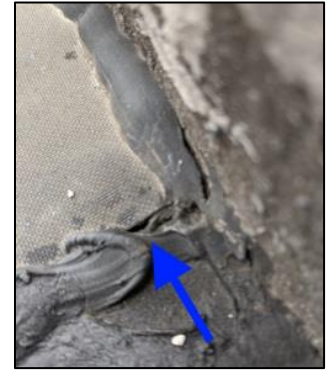
Parapet water entry

Concealed migration through roof/terrace construction

More than 40 feet of lateral travel

Interior leakage at kitchen ceiling

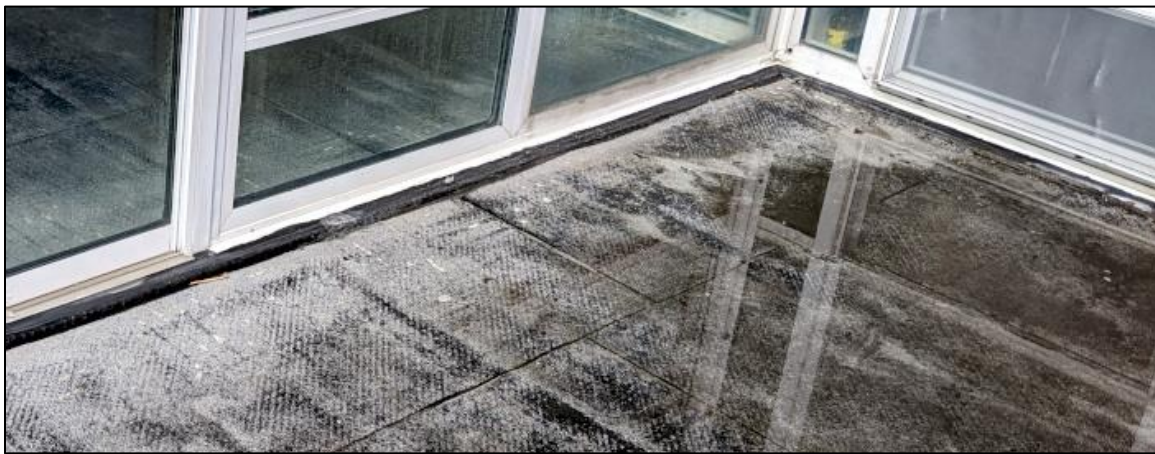
Targeted testing of plausible sources near the reported leak did not reproduce the interior leakage

The water was not simply passing vertically through the roof above the affected ceiling.

It was entering at the building perimeter, descending through the parapet, entering a concealed horizontal pathway above the structural slab, traveling across the roof assembly, and only then finding a route into the occupied space below.
