LEAK INVESTIGATION

Leak Investigation: A Case Study

Leak Investigation at a Non-Specific Mid-Rise Residential Building

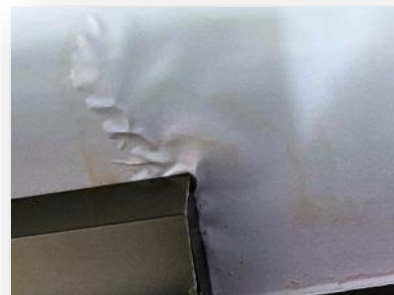
A mid-rise residential building in the Midwest, constructed with a typical 2010s-era envelope approach, suffered from persistent water infiltration for years. Storm after storm, residents and commercial tenants reported ceiling stains, moisture damage, and warped flooring—clear signs of a deeper, unresolved issue.

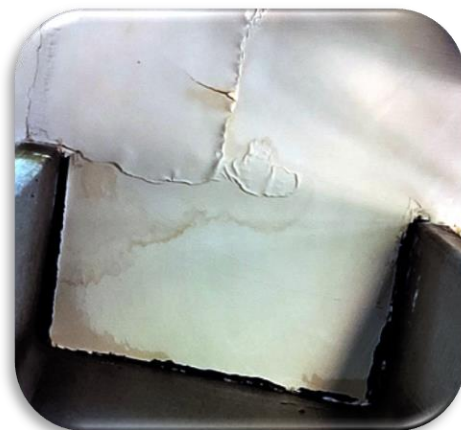
The building featured a storefront framing system used in a window wall capacity, a common “value engineering” approach that has led to performance challenges in similar buildings nationwide. The framed wall portions were clad with brick and metal panels, and the repeated water intrusion incidents left owners struggling to find a solution that wasn't just another temporary fix.

- **Subsill Flashing Deficiency** – The existing flashing below the storefront framing failed to function as a true barrier, allowing water to migrate into the structure—a common failure mode for this envelope design.
- **Backup Wall Membrane Breakdown** – Highlighted in yellow above, the weather-resistant membrane behind the metal panel cladding had failed, compromising its role as the primary barrier within the envelope system. Without a functional water-resistive barrier, water that breached the outer cladding had a direct migration path into subfloors, walls, and ceilings.

The primary barrier weather resistant membrane coating the framed wall behind the metal panel cladding no longer functioned as a primary water barrier. Consequently, the metal panel and adjacent fenestration systems were required to function in a surface barrier role, unable to properly manage water in a rainscreen/drainage capacity. Any water that breached the outermost visible planes of these systems would access a failed membrane providing direct ingress into subfloor, wall assemblies, and ceiling cavities below.

- **Sealant & Penetration Deficiencies** – The primary barrier had failed, forcing weatherseal sealants to act as a critical (rather than secondary) first-line defense. Unsealed fixture penetrations, open splice joints, and failing sealants all contributed to uncontrolled water entry challenging the deteriorating primary barrier nearly every time it rained.

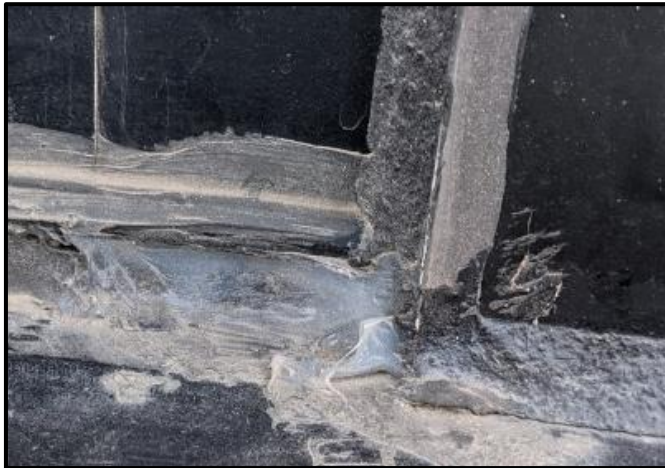
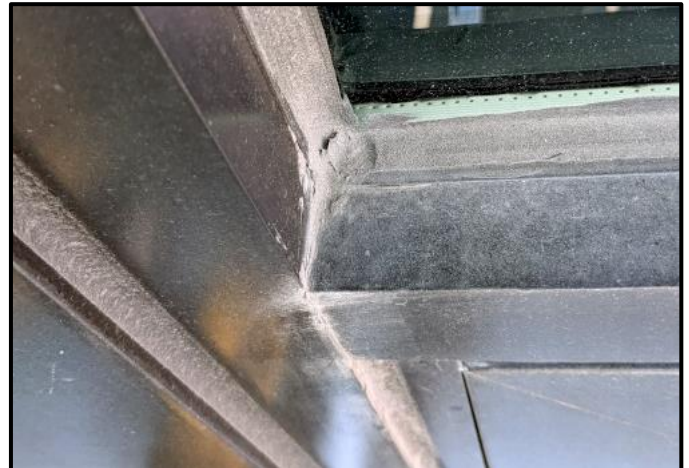
Failure Strata of Previous Surface-Level Remediation Attempts

After multiple contractor-driven attempts to resolve the issue with surface-level sealant repairs, the building owners sought a more comprehensive assessment and engaged a building envelope consultant for an expert opinion. The consultant's report was exhaustive in length but lacked any definitive failure point identification necessary for effective remediation.

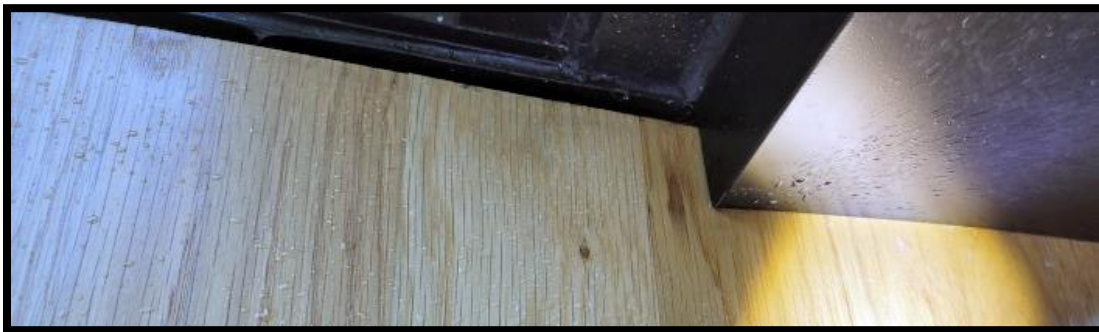
Findings: Why the Building Was Leaking

Primary Issue: The primary WRB membrane was compromised, offering no protection.

Impact: Water freely migrated into subfloors, walls, and ceilings, accelerating damage.

- Hightower Labs' root-cause findings were addressed by a contractor. Even with client-directed non-destructive investigation limitations, we ensured maximum accuracy without unnecessary demolition or cost burden.
- Since remediation was implemented in 2022, the leaks have not returned.
- The owners now have full confidence in their building envelope.
