# LEAK INVESTIGATION

## *Case Study | Mid-Rise Residential*

*A recurring kitchen ceiling leak persisted through years of inspections, sealant repairs, roofing work, and ultimately replacement of the penthouse roof above. A one-day diagnostic investigation identified the actual water-entry source more than 40 feet away.*

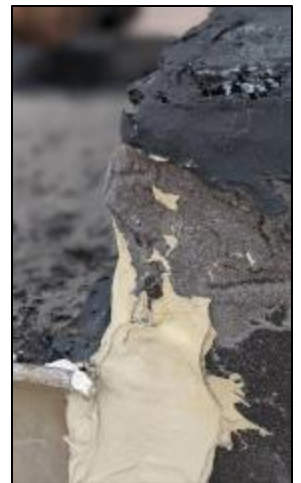
The prior efforts were not necessarily unreasonable. Each addressed building components that could plausibly contribute to leakage based on the location of the interior symptom. The difficulty was that the location where water became visible inside the building did not reveal where the water was entering the enclosure.

Without establishing the actual water-entry point and migration path, successive repairs continued to address suspected sources rather than a verified failure mechanism.

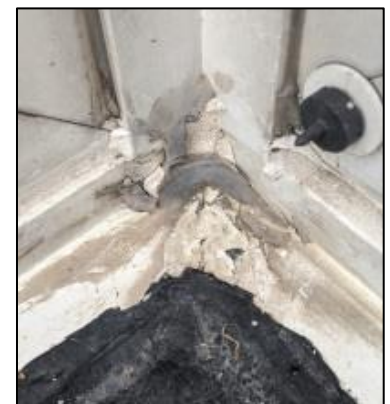
When the source of a leak has not been verified, additional repair work can become increasingly expensive without addressing the actual water-entry path.
